قناطر نجع حمادى الجديد

مشكلة البيزوميتير B10

GROUTING OF OPEN BOREHOLE IN THE CONSTRUCTION PIT AREA

Prepared by :Eng .Salah awad
3 November 2004

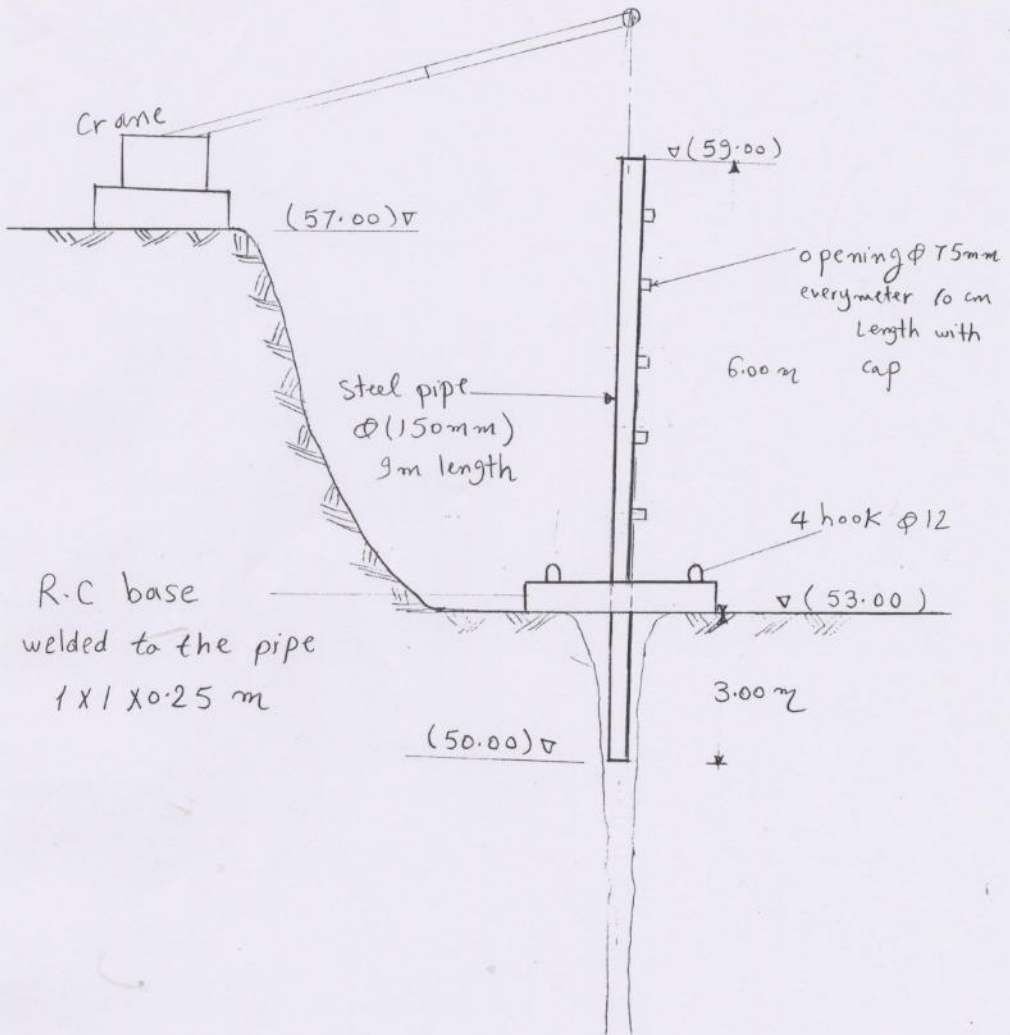
Fig. No. 3-1-A

Grouting Solution first stage.

(installation of base Concrete with the steel pipe)

تم اقتراح قاعدة خرسانية مسلحة سابقة التجهيز بأبعاد 1.5م*1.5م*0.3 م (وزن حوالي 1.7 طن) مزودة بماسورة قطر 15سم توضع فوق فتحة البئر مصدر المياه عند منسوب (53.00)

يتم لحام الماسورة مع جزء اخر بنفس القطر حتى منسوب 59.00 وبذلك يكون طول الماسورة الكلى 9 امتار 3+6 اسفل القاعدة الخرسانية.

B- on 14-9-2004 Installation of base concrete 1.00*1.00*0.25 m with reinforcement 6Φ16/m occupied with 4 hook Φ12 mild steel 4*1m at precast yard

C- On 15-9-2004 A steel pipe 9.00m long Φ(150mm) was prepared at the precast yard with six vents Φ(75mm) steel pipe 10 cm long each at precast yard

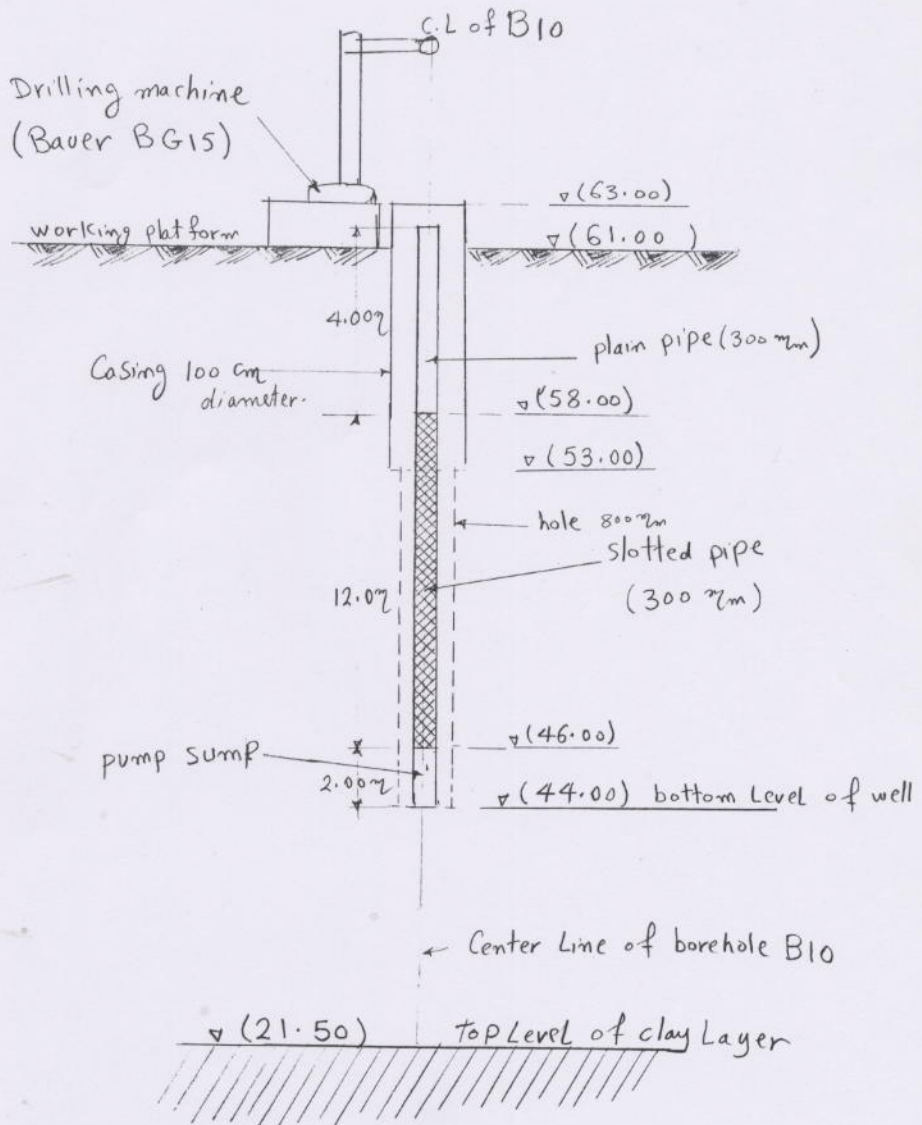
Fig. 3-2 Solution No 2

Installation of a well.

one possibility is to create a filtered well above the spring to get the water under control, which means that no fines shall be washed out and the water shall be conveyed outside of the foundation area into a sump .

later on after establishing the foundation of the navigation lock, the well may be grouted with cement grout . For this reason grouting pipes shall be installed in the well during its construction.

The execution of the well above the spring can be done from a level depending on the available casing and specific dimensions of a drilling rig . Considering the available equipment at site (Baure BG 15) which was used for drilling deep wells .the drilling could be started from a plat form at level of about 61.00m asl using the casing of appr. 6.00and 11.00m . the 11.00 m casing could be installed from (65.00) to(54.00)m asl and the drilling could be done inside down to appr.44.00m asl under a constant head of water to the rim of the casing . A slotted filter pipe with a pump sump at the bottom could be installed for controlled pumping in order to facilitate foundation works.

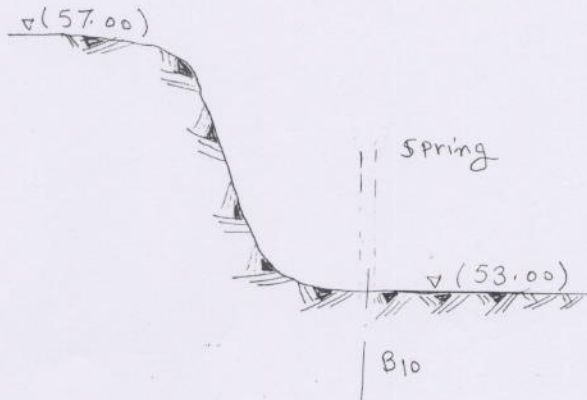
Fig. 4-A

After study the problem which happened in the construction pit area at Navigation locks area .It the most probably that the main reason of the leakage that this boreholes (B10) was not grouted along it's entire length .

Spring in Navigation Lock area up stream
at Level (53.00)

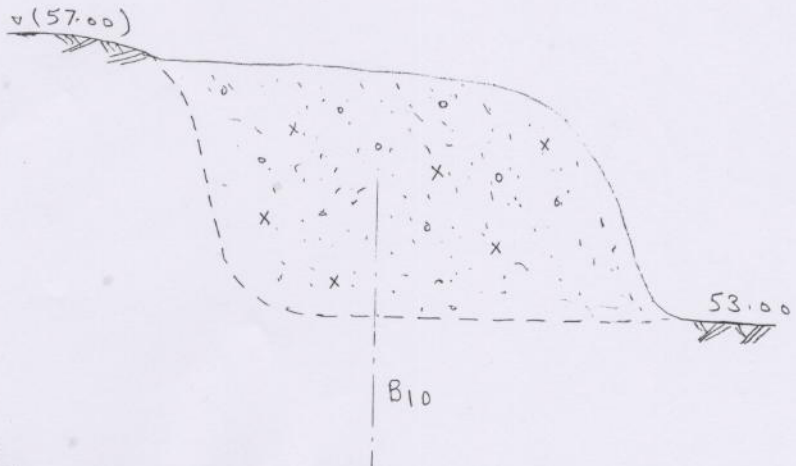
Fig 4-B

Back filling with Sandy Gravel Soil to stop water Leakage.

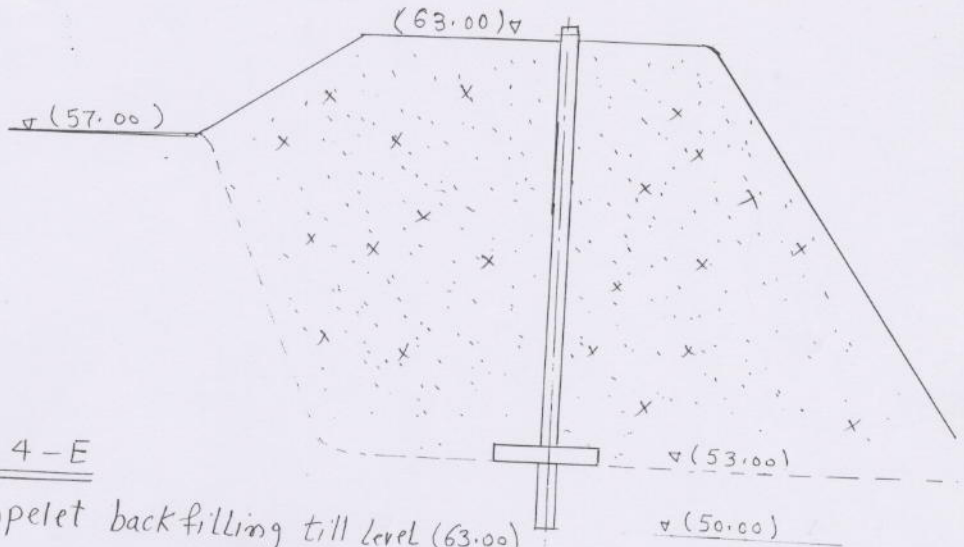
Fig. 4-E

Complete backfilling till level (63.00)
and increase the length of the pipe.

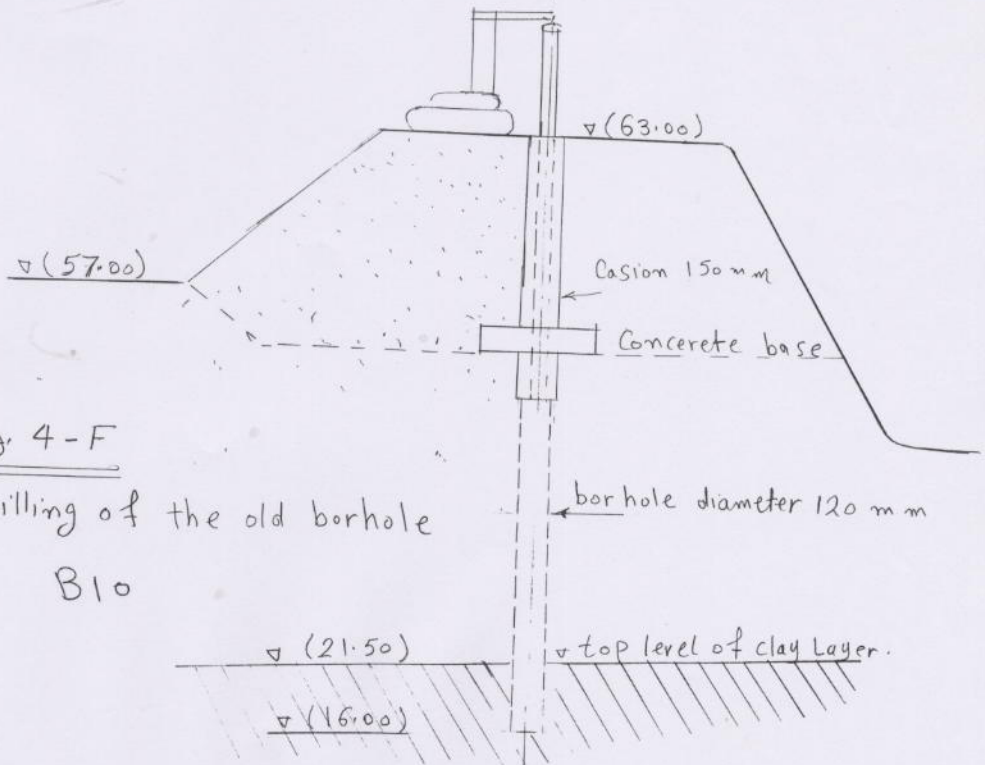
Fig. 4-F

Drilling of the old borhole
B10

H- On 26-9-2004 Drilling of the old borehole no B10 by using 3 inch diam. Pipe with rotary drilling method which done by geotechnical Egypt. during drilling process, it was observed losses of bentonite from level(63.00) till level (26.00) after bentonite losses stopped, The drill operator felt nature soil and gravel layers. The drilling continued till top of clay layer at level (21.50), bentonite slurry for excavation was coming up with traces of old grout (cement). The drilling reached at level (16.00)

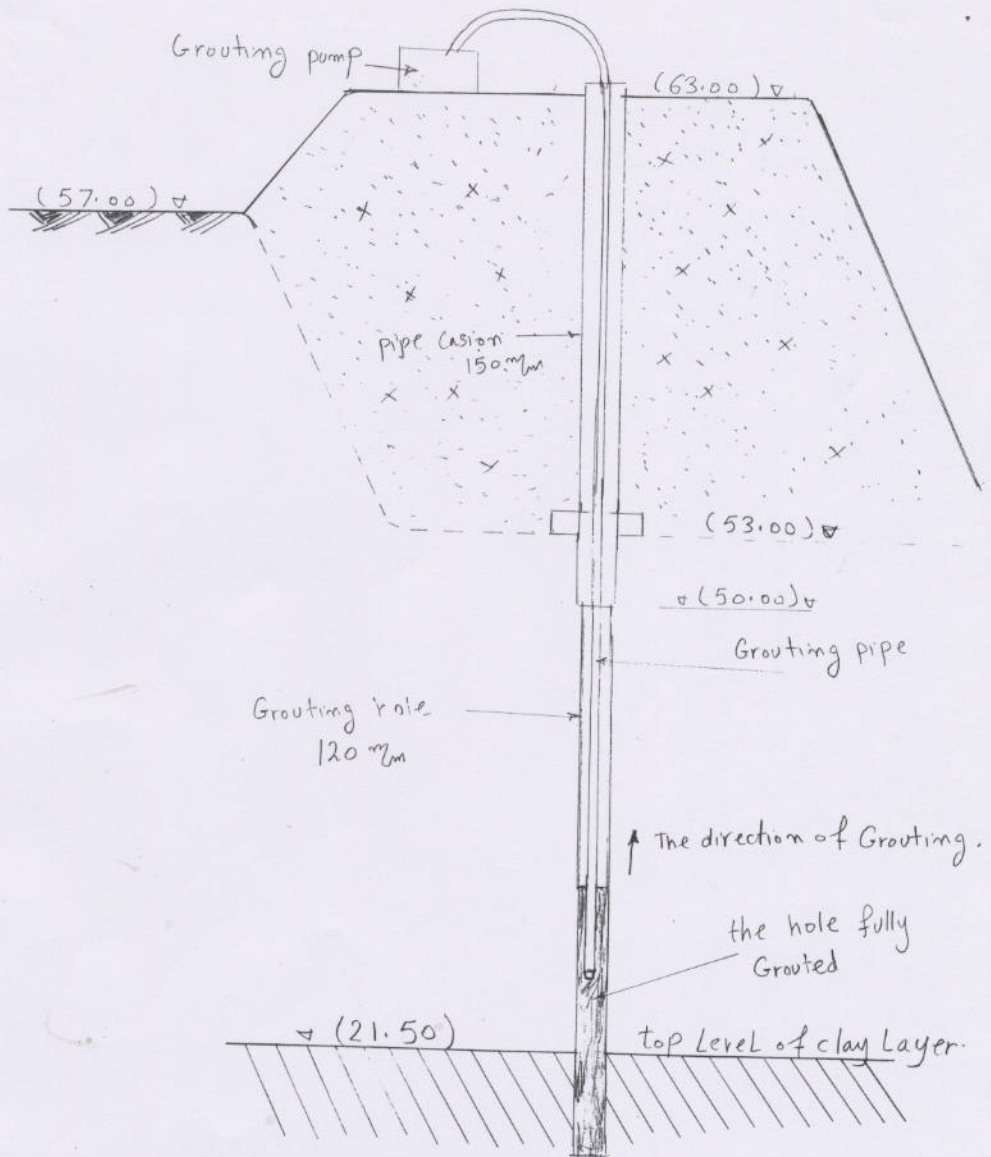
Fig. 4 - G

Grouting of the old Bore hole B₁₀

I- After reaching at level (16.00) with penetration 5.5m inside the silt and clay layer the grouting was started with cement and water ratio 1.5:1 and continued till the top of platform.
